**MOUSAM RIVER BASIN
SHAPLEIGH, MAINE**

**EMERY MILLS DAM
ME-00186**

**PHASE I INSPECTION REPORT
NATIONAL DAM INSPECTION PROGRAM**

OCTOBER 1978

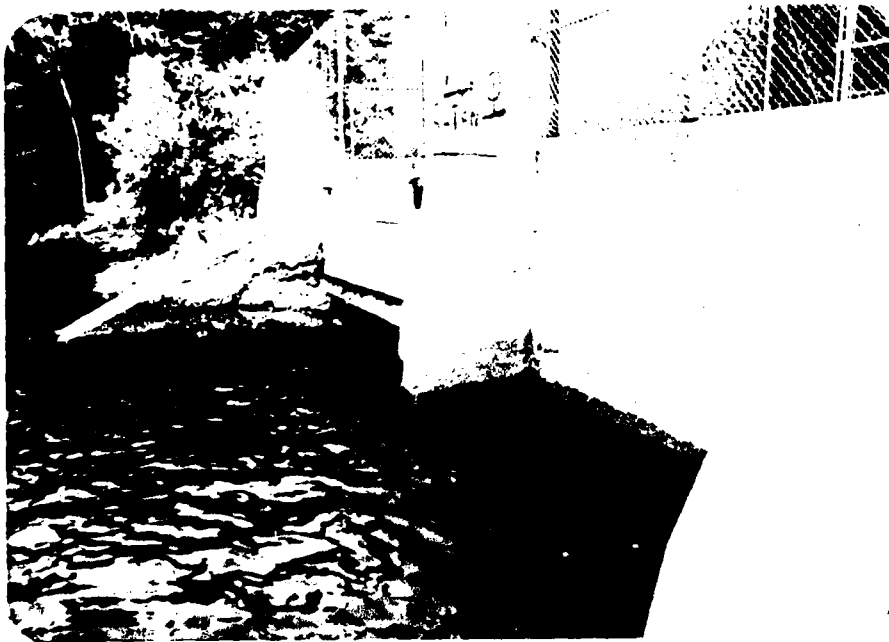
3

- (a) The dam structure appears to be true to line and grade; no horizontal or vertical movement was observed.
 - (b) Some spalling of the concrete surfaces in the areas of the controlled outlet gatehouse has occurred. See photograph 3.

Condition of Concrete	Fair - some spall
Stop Logs and Slots	None
Debris Screen	Heavily loaded with debris - no method apparent for clearing

CONTROL GATE INTAKE STRUCTURE

5. Repair areas of spalled concrete.
 6. Provide around-the-clock surveillance during periods of anticipated high runoff.
 7. Develop a formal warning system and implement its use in the event of an emergency.

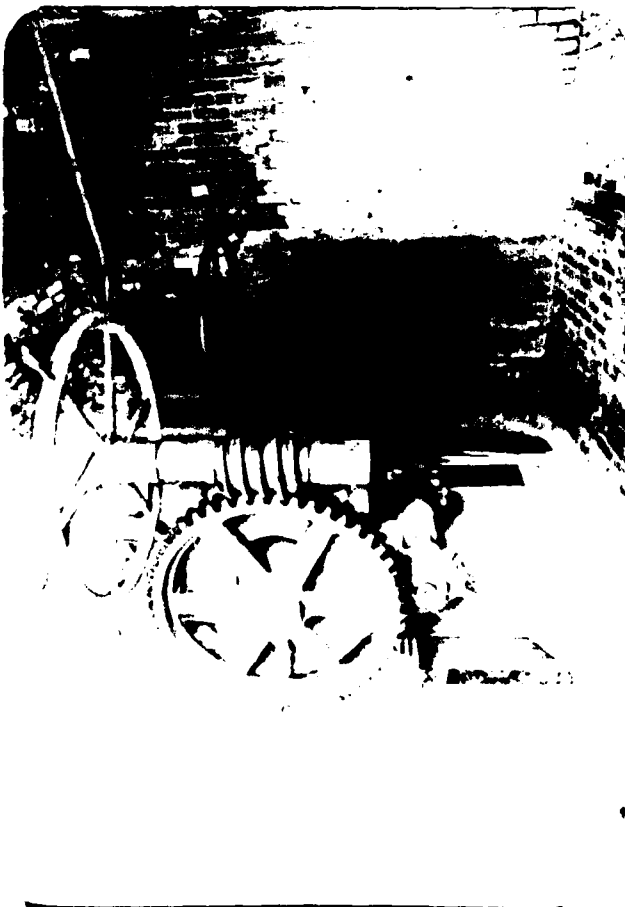
4

CONTROL GATE MECHANISM

- b. Operating and Emergency Control Gates - the gates are raised by means of a vertical rack and gear. The gate stems, one for each gate, consist of steel beams. These beams appear to be in good condition; very little corrosion has occurred. The gate operating equipment was found to be in good repair. See photograph 4. The gates were operated during the inspection and it was observed that they operated properly.
